# THE INFLUENCE OF PERFORMANCE ENGINEERING ON DISASTER RECOVERY: PRIORITIES FOR LIMITING DOWNTIME

**Mary C. Comerio**

*University of California, Berkeley USA  
Email: mcomerio@berkeley.edu*

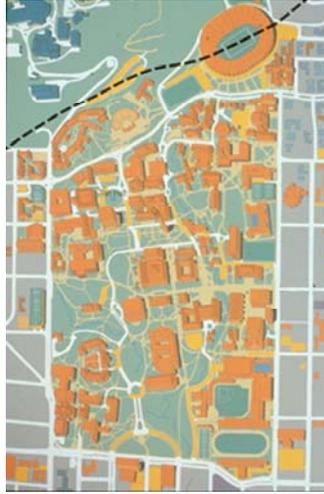
**Figure 1. Location of Testbed Building Relative to the Hayward Fault**

The case study building is located in the southwest quadrant of the campus, within 2 km of the Hayward fault. The building was completed in 1988, intended to provide high technology research laboratories for organismal biology. The building is essentially rectangular in plan and is nominally 100 feet wide and 300 feet long, and 6 stories, plus a basement. The lateral force (seismic) resisting system consists of discrete concrete shear walls in the transverse direction and exterior concrete wall-frames (or "punched shear walls") in the longitudinal direction as shown on the plans, Figure 1. These shear walls provide great lateral stiffness to the building, on the one hand preventing large lateral displacements between floors ("drift"), but on the other hand enabling the building to transmit and amplify strong ground motions to each floor level. Walls, other than the concrete shear walls, exterior walls, and shaft walls, are made of steel studs and gypsum board and are considered nonstructural (although, in some cases they can provide support for contents). Typically, ceilings are open with exposed mechanical piping in the laboratories. Some offices contain acoustical drop ceilings, but most are exposed. The floor is either vinyl tile or exposed concrete. The mechanical systems are sophisticated, as one would expect of a modern laboratory building.

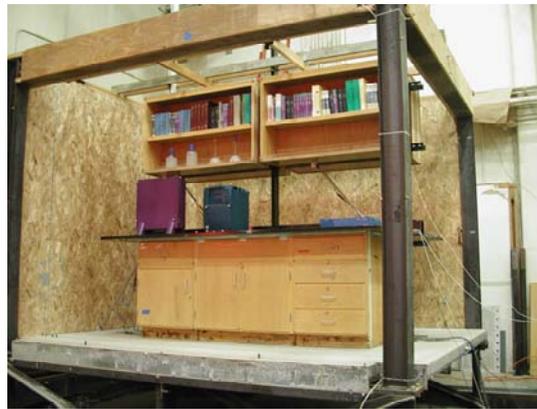
**Figure 3 Bench and Shelf system on the Shake Table at U. C. Irvine**

The building was analyzed using the PEER OpenSees structural methodology by Khalid Mosalam [7] at University of California, Berkeley to produce roof and floor displacement data (known in the PEER terminology as Engineering Demand Parameters or EDPs) to be used by Nicos Makris [8] (U. C. Berkeley) and Tara Hutchinson [9] (U. C. Irvine) who did laboratory tests of critical heavy floor-mounted equipment and bench-top configurations and equipment. Both sets of researchers postulated that the seismic excitation would result in sliding-dominated (rather than rocking dominated) responses based on size and configuration of typical components. For simplification, neither testing program considered vertical motion input. Similarly, each researcher used different earthquake input motions because the objects and the shaking table capacities were different. The horizontal displacement capacity is approximately six inches for the Berkeley table and ten inches for the Irvine table, so tests were only done for ground motions within the limits of the tables. Numerical simulations were necessary to project equipment behavior for larger displacements.

The results of the shake table tests for bench-top equipment show that the maximum displacement (based on an average of multiple positions) relative to the bench surface is less than 10 cm (4 inches) for a Peak Horizontal Floor Acceleration (PHFA) below 0.8g. Based on the ground motions, using Peak Horizontal Floor Acceleration as an EDP, the amplifications at the bench tops and the coefficients of friction, the seismic fragility curves were created. The results of the tests for heavy equipment produced results of peak sliding distance (PSD) ranges between a low of about 2.5 cm (one inch) to a high of almost 61 cm (24 inches).

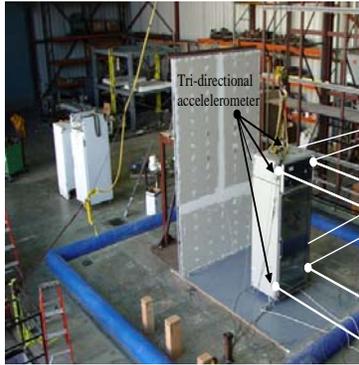
Figure 5 Heavy Equipment on the Shake Table at U. C. Berkeley

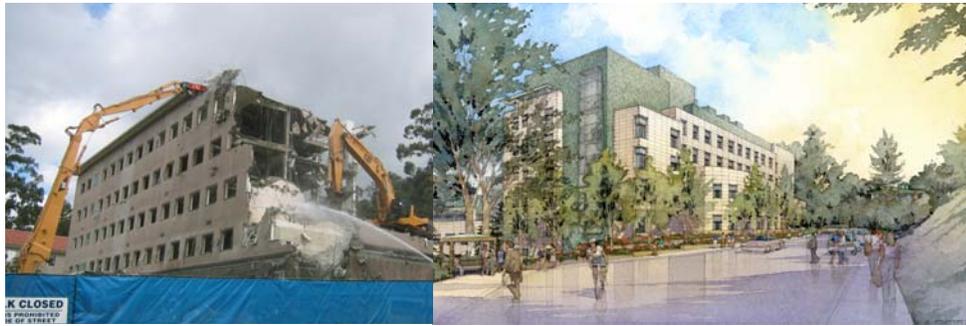
**Figure 6 Demolition and Replacement of a Critical Laboratory Building**

Overall, the planning performance goal was to limit a campus closure to 30 days or less, so that a semester would never be cancelled due to earthquake damage. For each major function, classrooms, laboratories, libraries, offices, etc.—space was analyzed in terms of its structural and non-structural performance and retrofit priorities were adjusted to reflect the overall risk. Laboratories were particularly vulnerable. Three of the five key laboratory buildings were collapse hazards and a decision was made to replace these buildings with new structures rather than risk post-earthquake damage that could result in closure of retrofitted buildings. Similarly, critical computing services were moved to a new facility. New food service buildings were also designed to be operational after an earthquake.
